SUB-BASES

THE OTHER HALF
OF THE FIELD

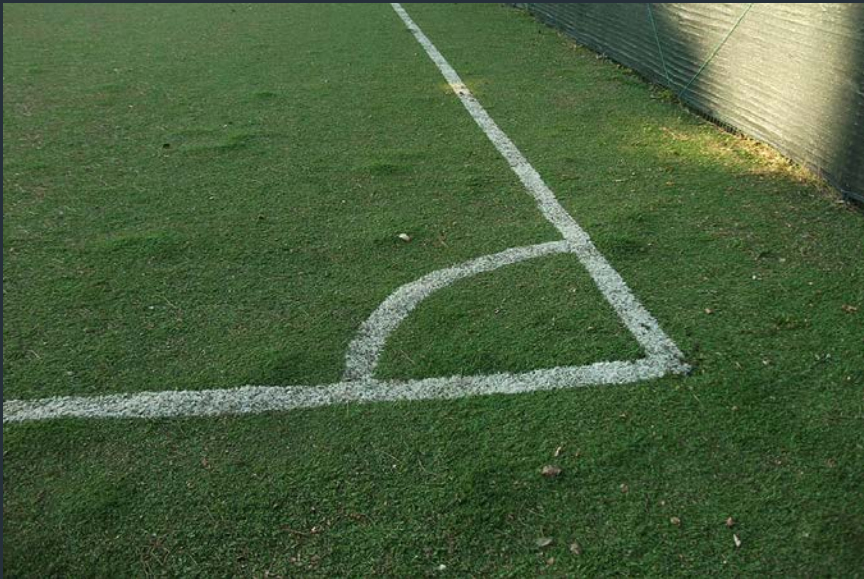
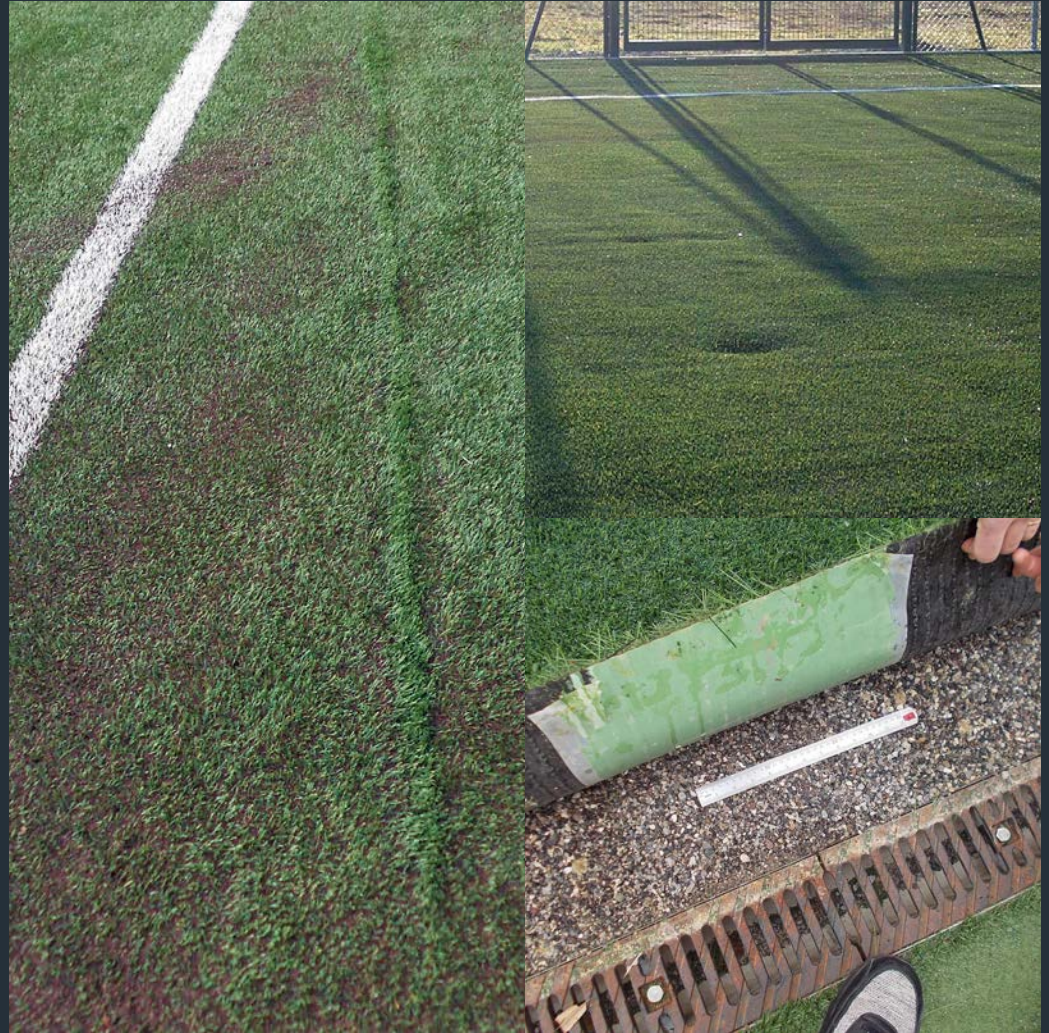
BUT SOMETIMES...

We find moles, grooves, golf courses and an irregular backing.

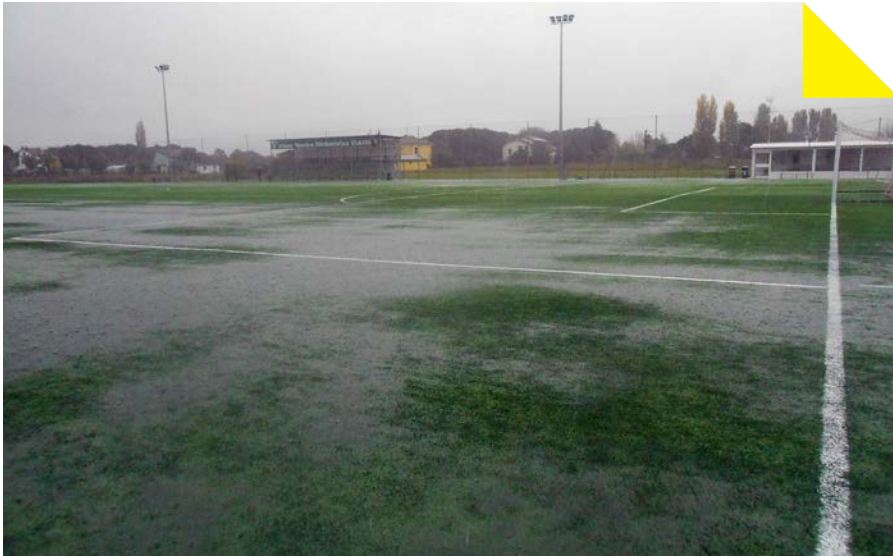
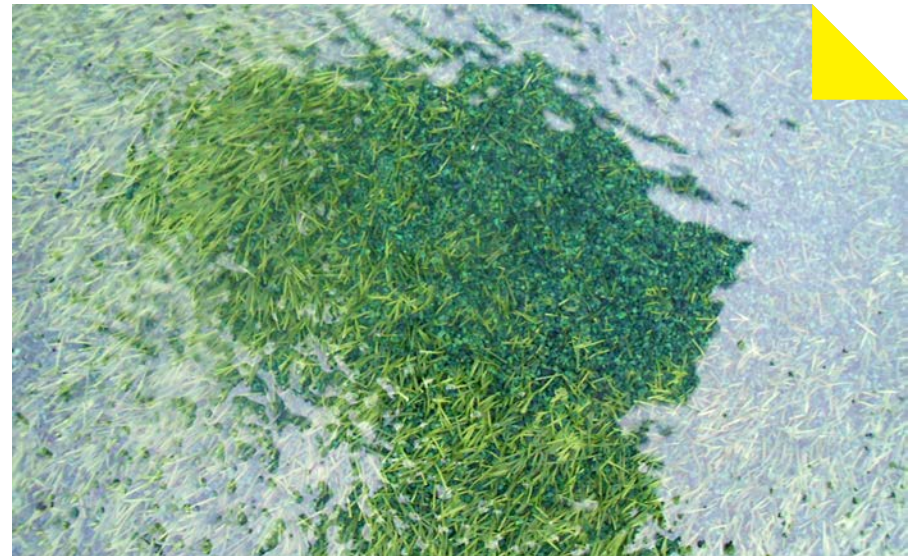
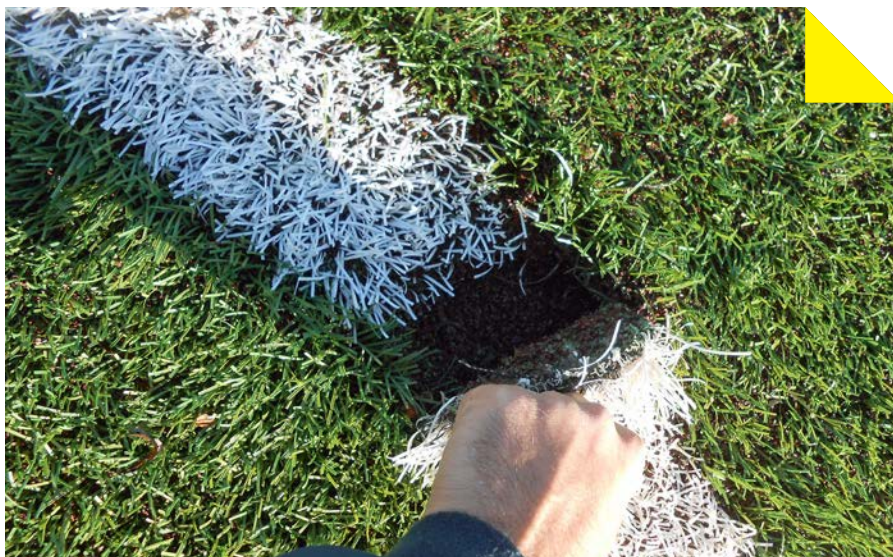
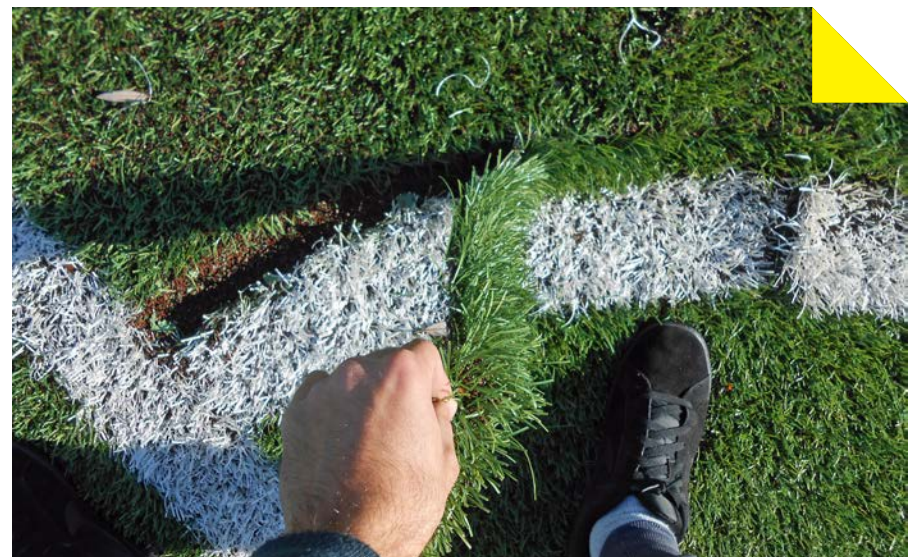
IN OTHER CASES...

We find puddles and playing lines...

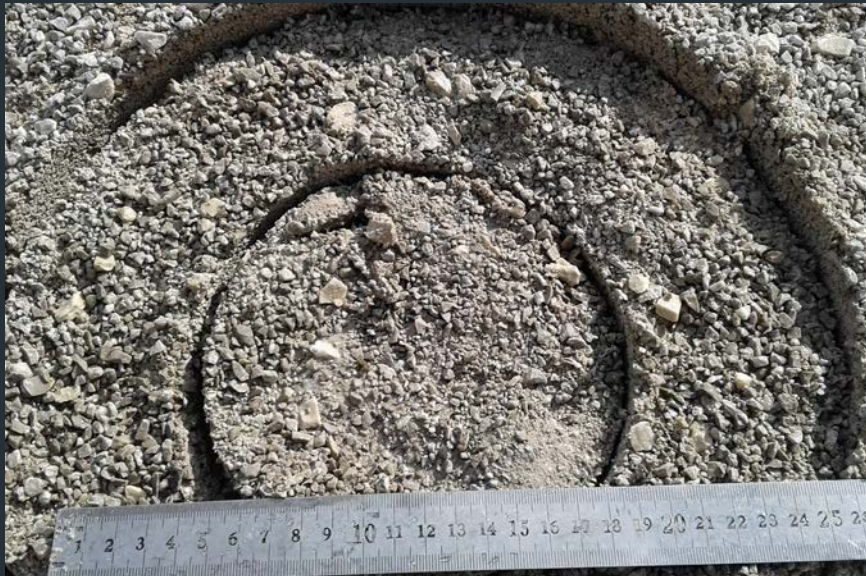
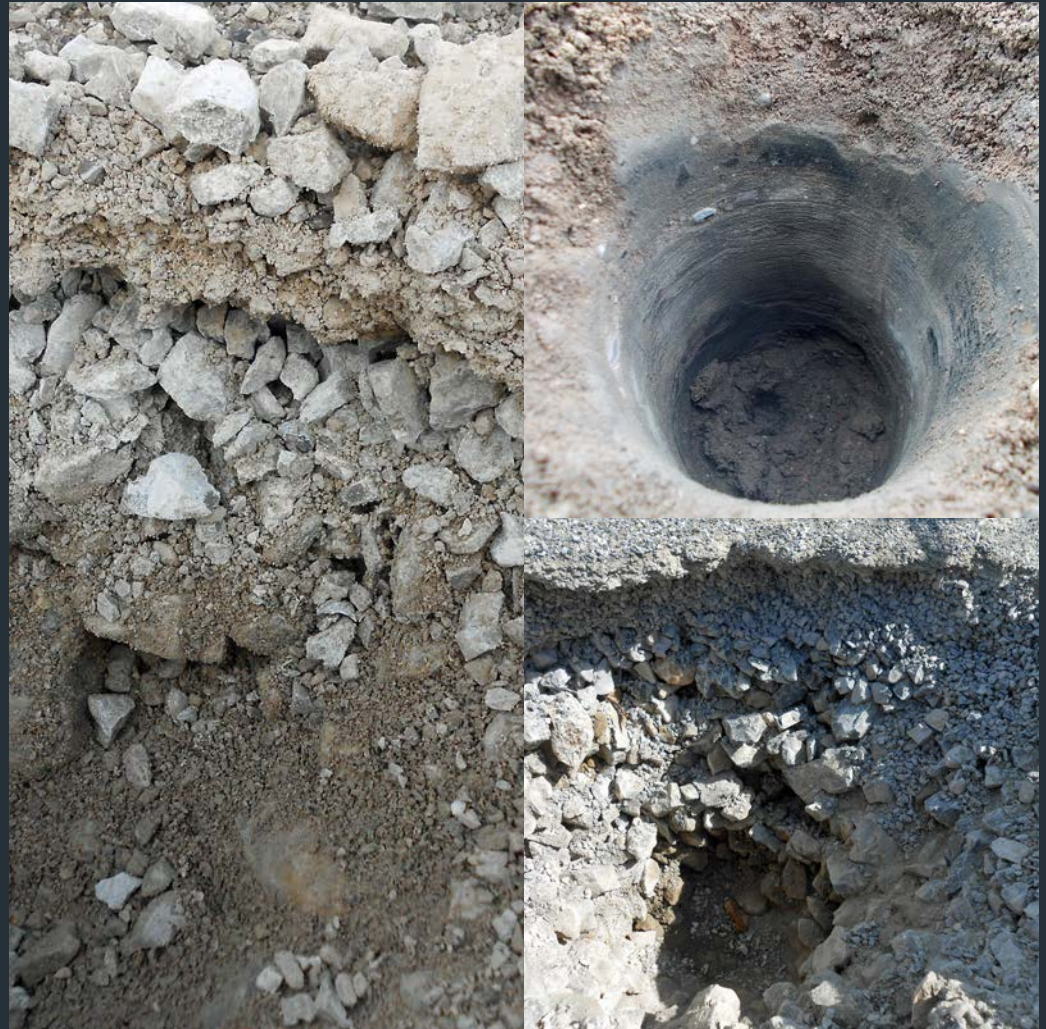
LET'S CHECK THE SUB-BASE

The picture on the right shows an example of a good job and two cores drilling, one positive and one negative. The picture here below shows a well-executed vertical drainage .

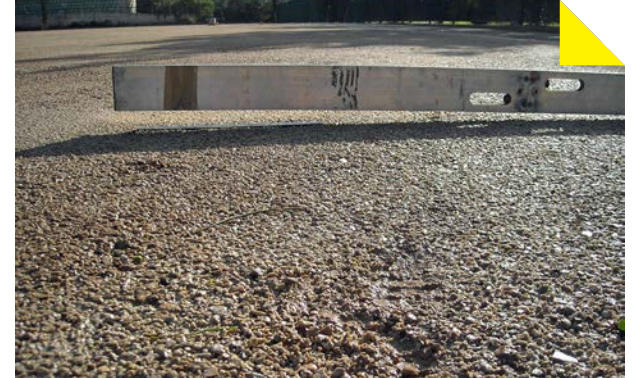
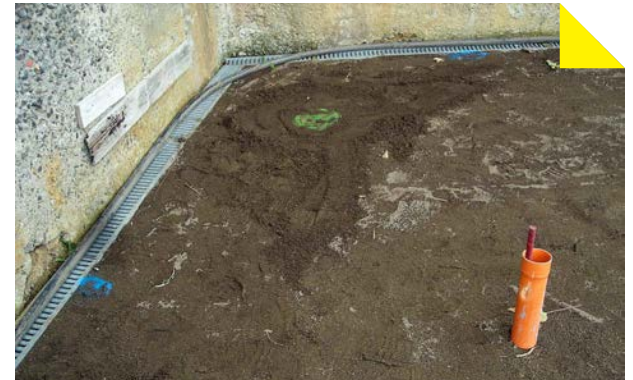
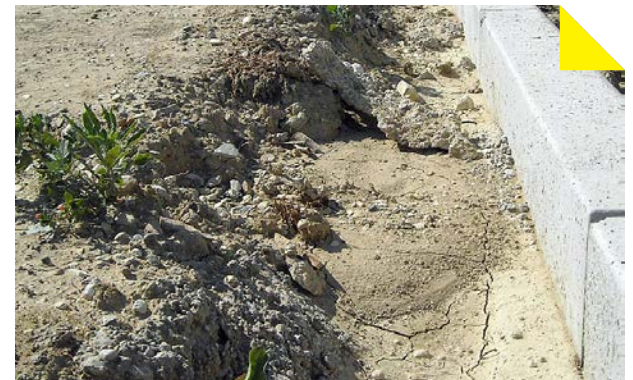
THE FOOTPRINT OF CRIME

On a work well done footsteps must not appear when you walk on the sub-base because in this case is impossible to install the synthetic turf . Then the sub-base should be smooth and compact, in the same way it needs to pay attention also to external areas and we should not find clay that makes impossible the drainage.

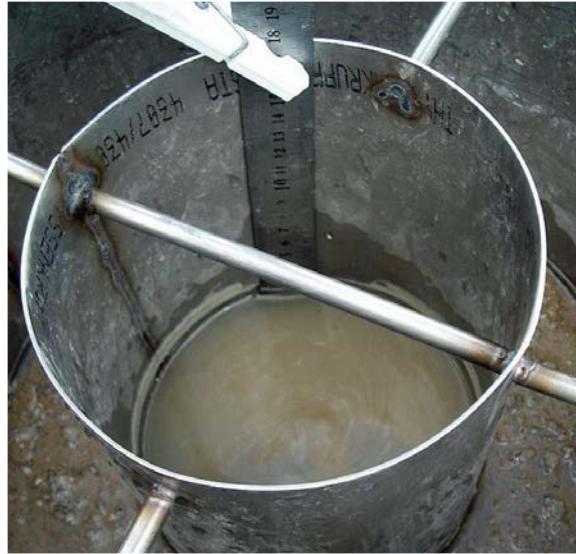
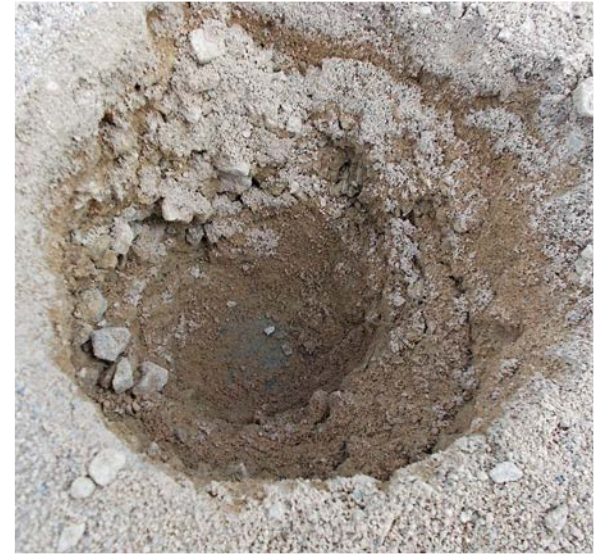
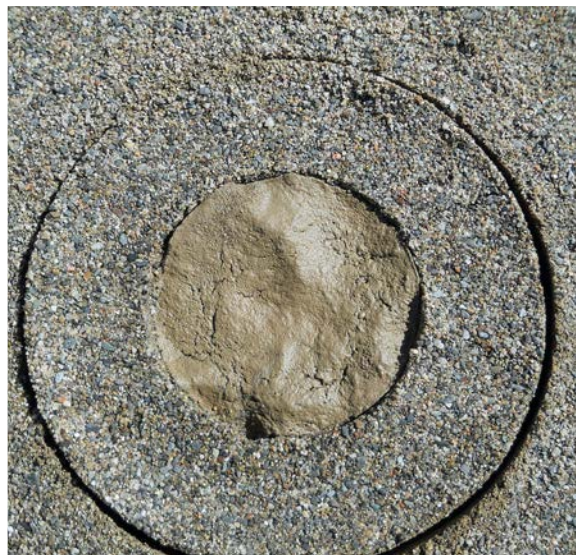
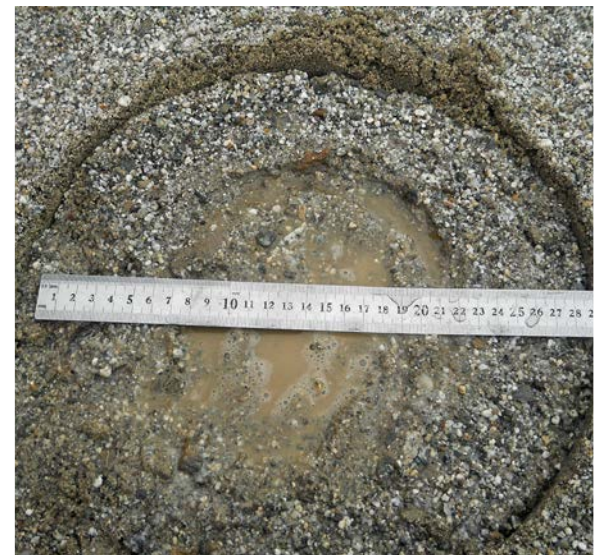
WHEN THE DRAINAGE...

Four examples in order to explain how a poorly executed work leads to find sub-bases that do not allow the correct drainage of water, consequently involving the correct reconstruction of the work.
