**COMMON DIFFICULTIES ON SPORTS
FACILITY CONSTRUCTION
IN REGARD OF DESIGN & CIVIL WORKS**

HOW TO SOLVE IT!

BERT HAMMES

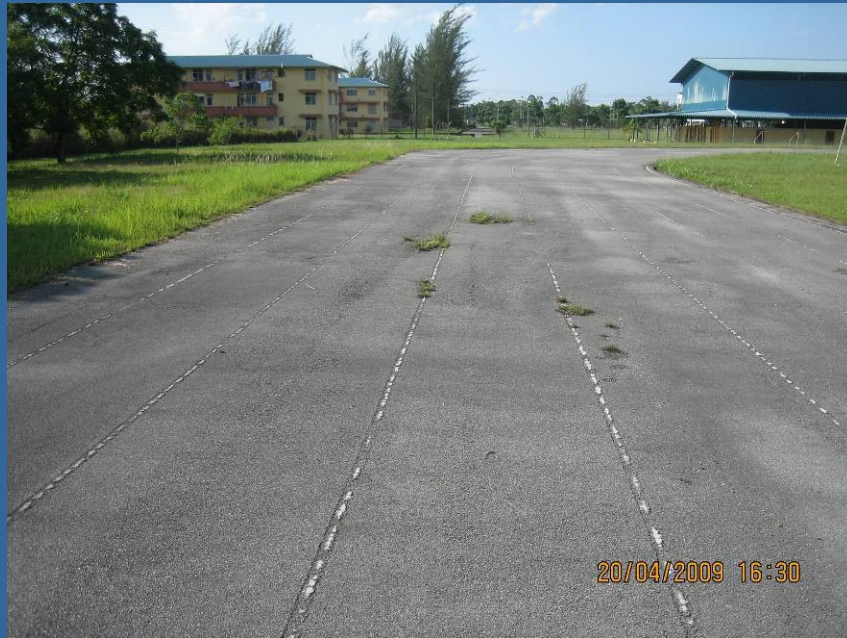
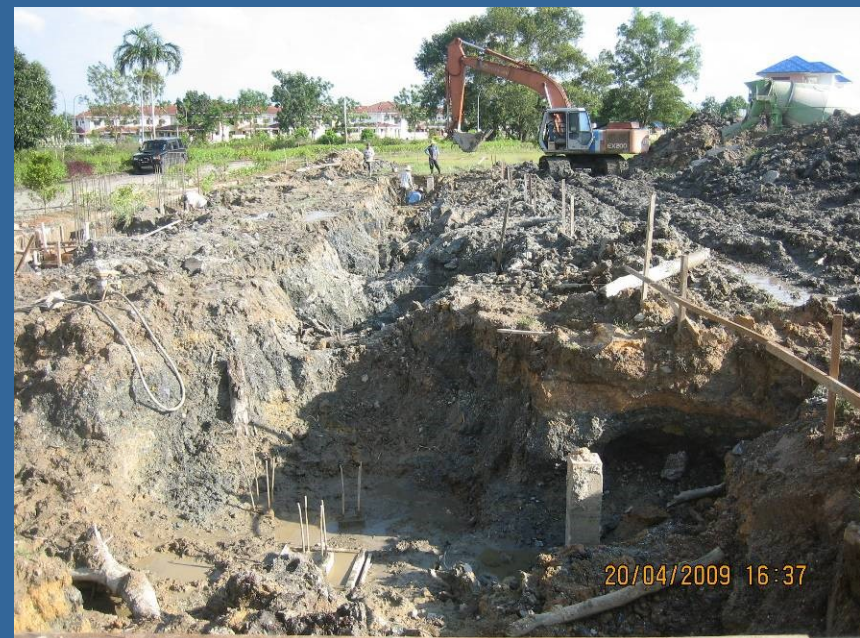
Understanding site conditions

- Need to assess site prior to construction
 - You need to understand what is underground

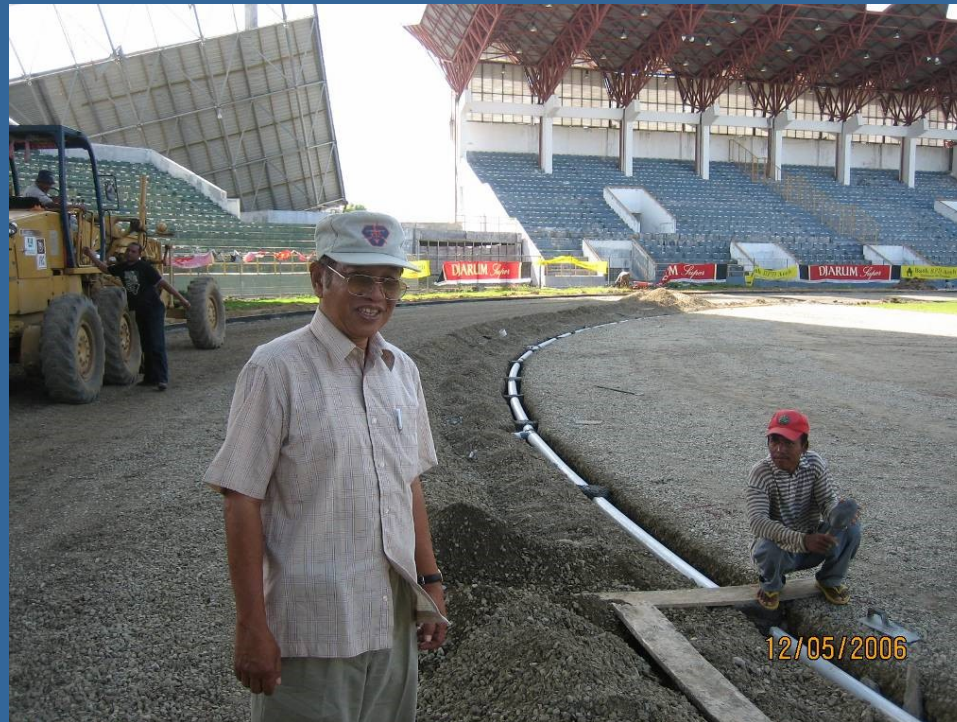
Understanding site conditions

- Adapting design to utilise existing infrastructure can provide large cost savings

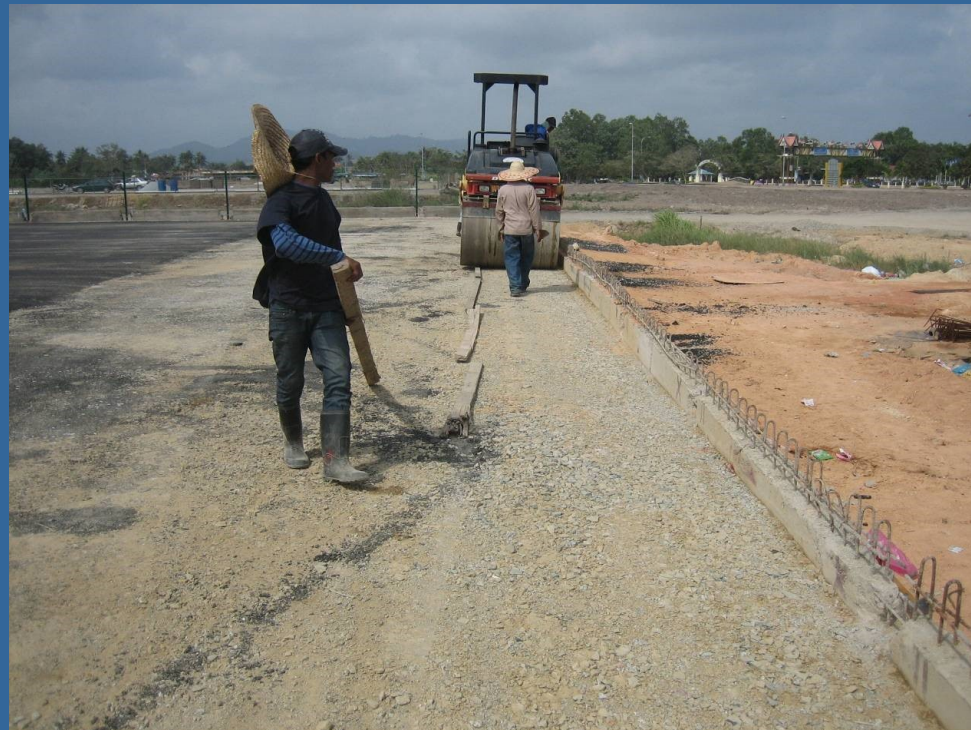
Civil Works - Compaction

- Concentrated compaction along trench backfill & edges

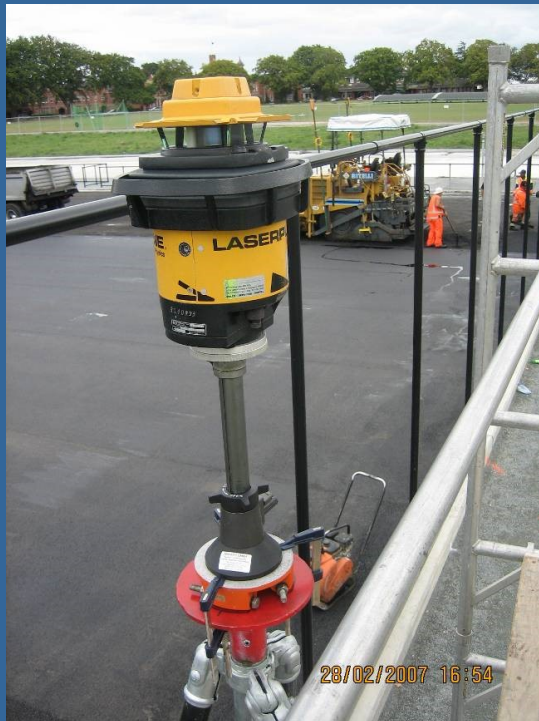
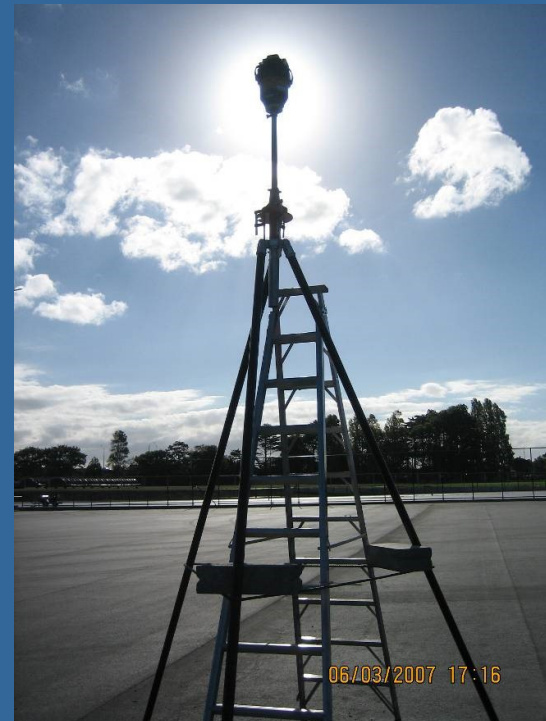
Level control – laser guided systems

- Laser mounted on tripod above machinery level for constant laser signal

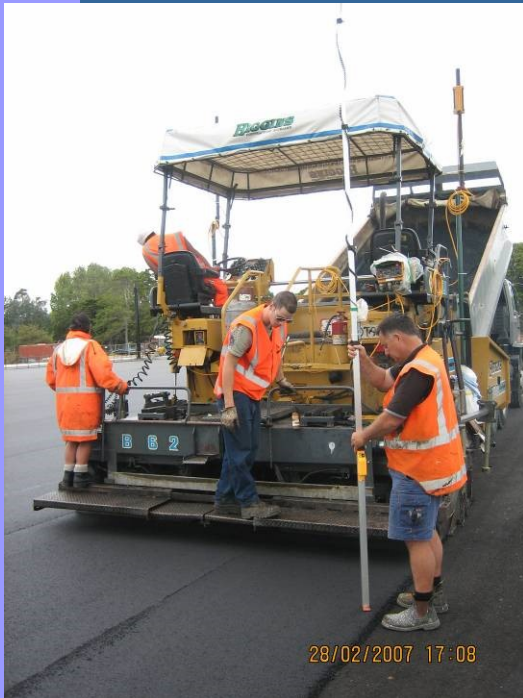
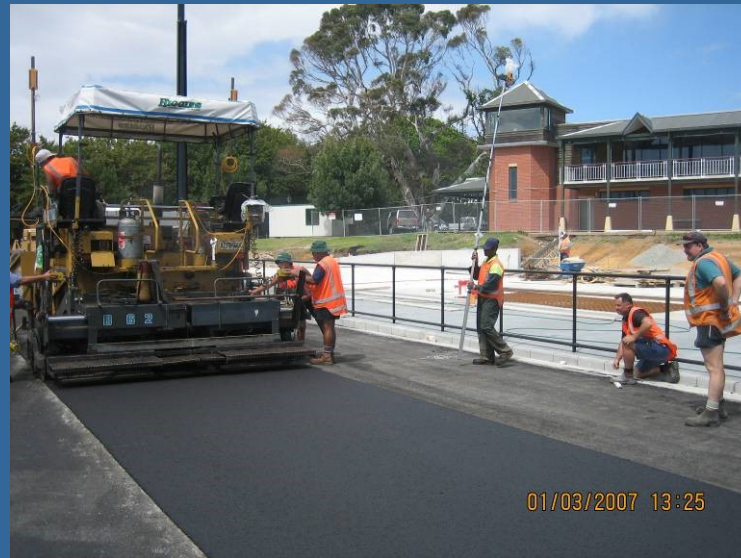
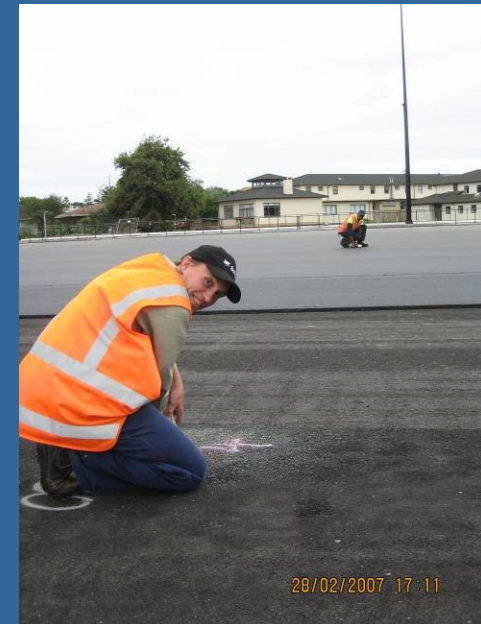
Level control – laser guided systems

- Constantly check levels with laser & string line

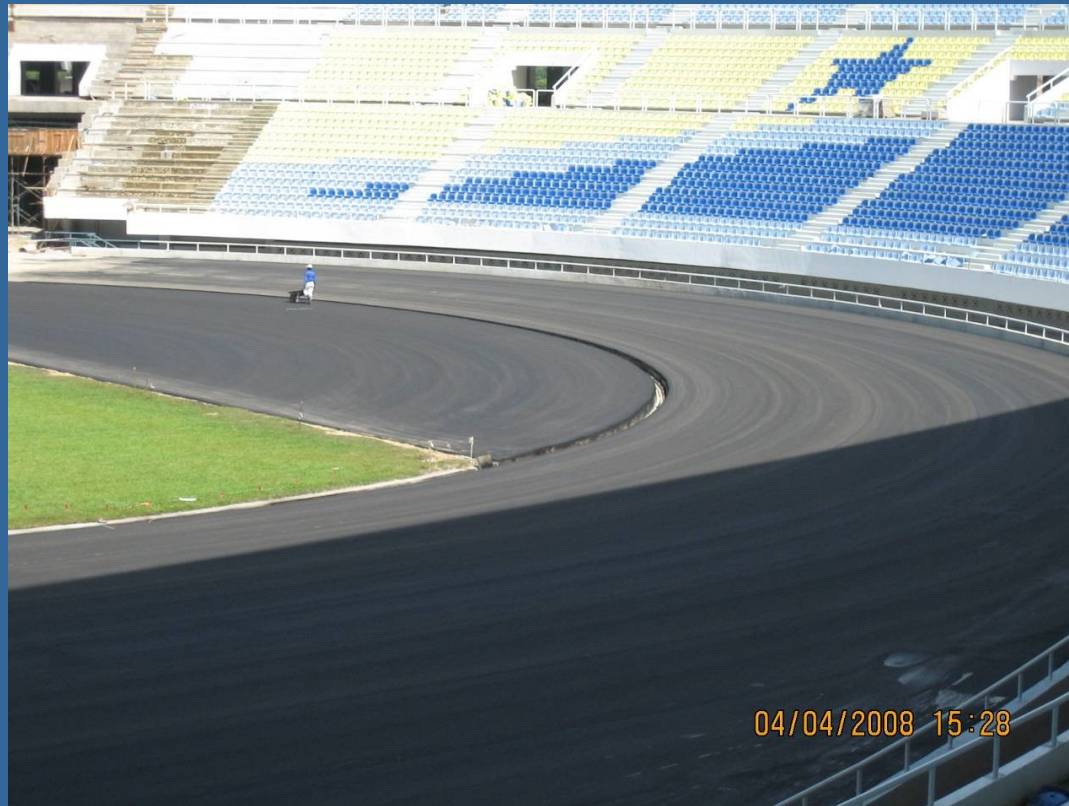
Level control – laser guided systems

- Paving method & orientation critical
